## Where we are now with the restoration of Notre Dame after the rejection of modern architectural gestures

An insider report from the site on the latest discoveries and re-building techniques

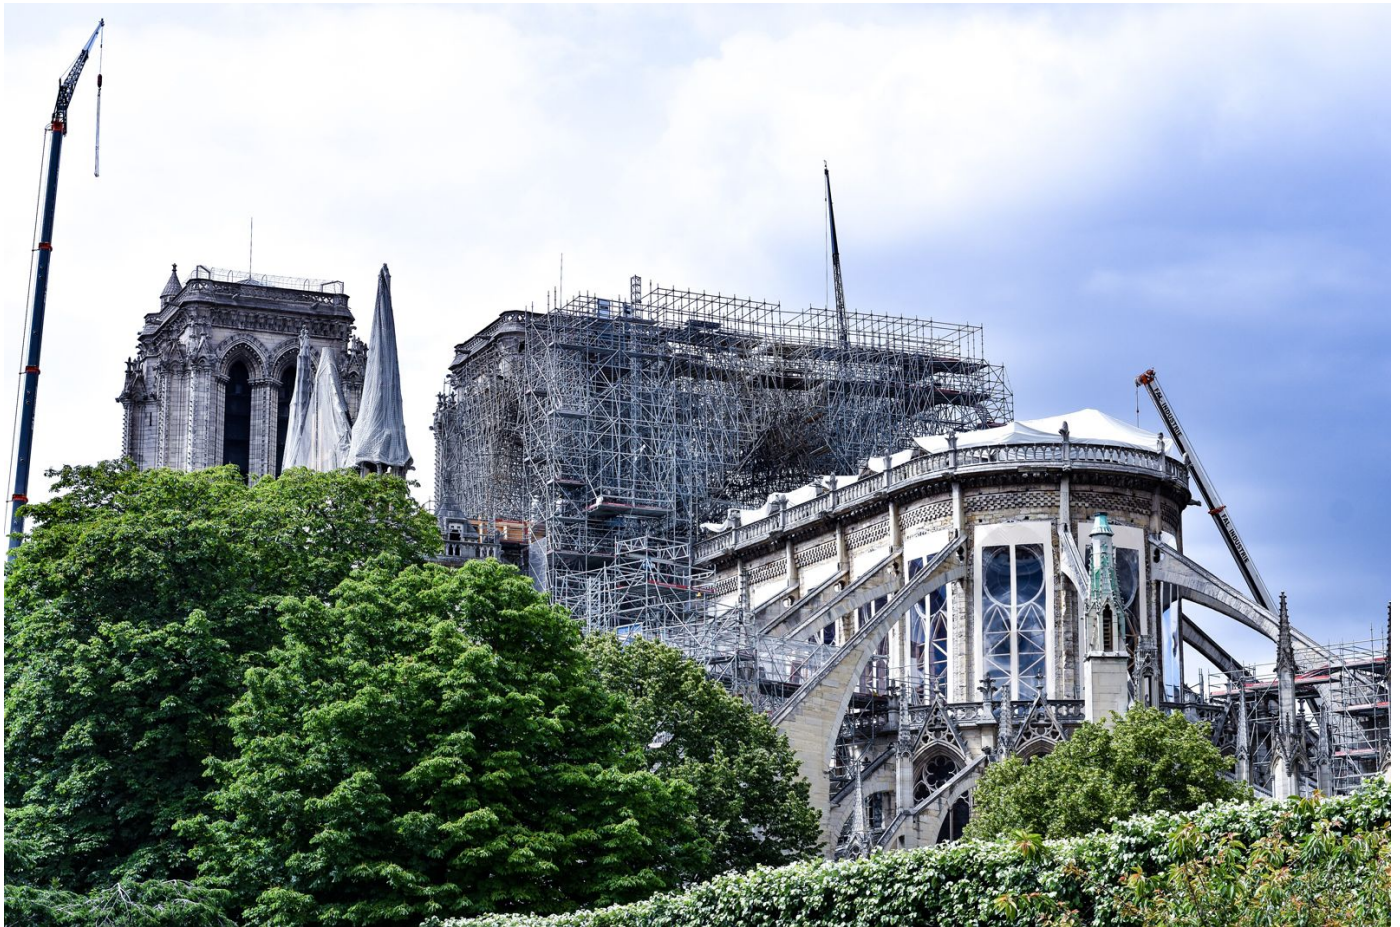
The cathedral of Notre Dame a few weeks after the fire in 2019 © Tayla Bundschuh

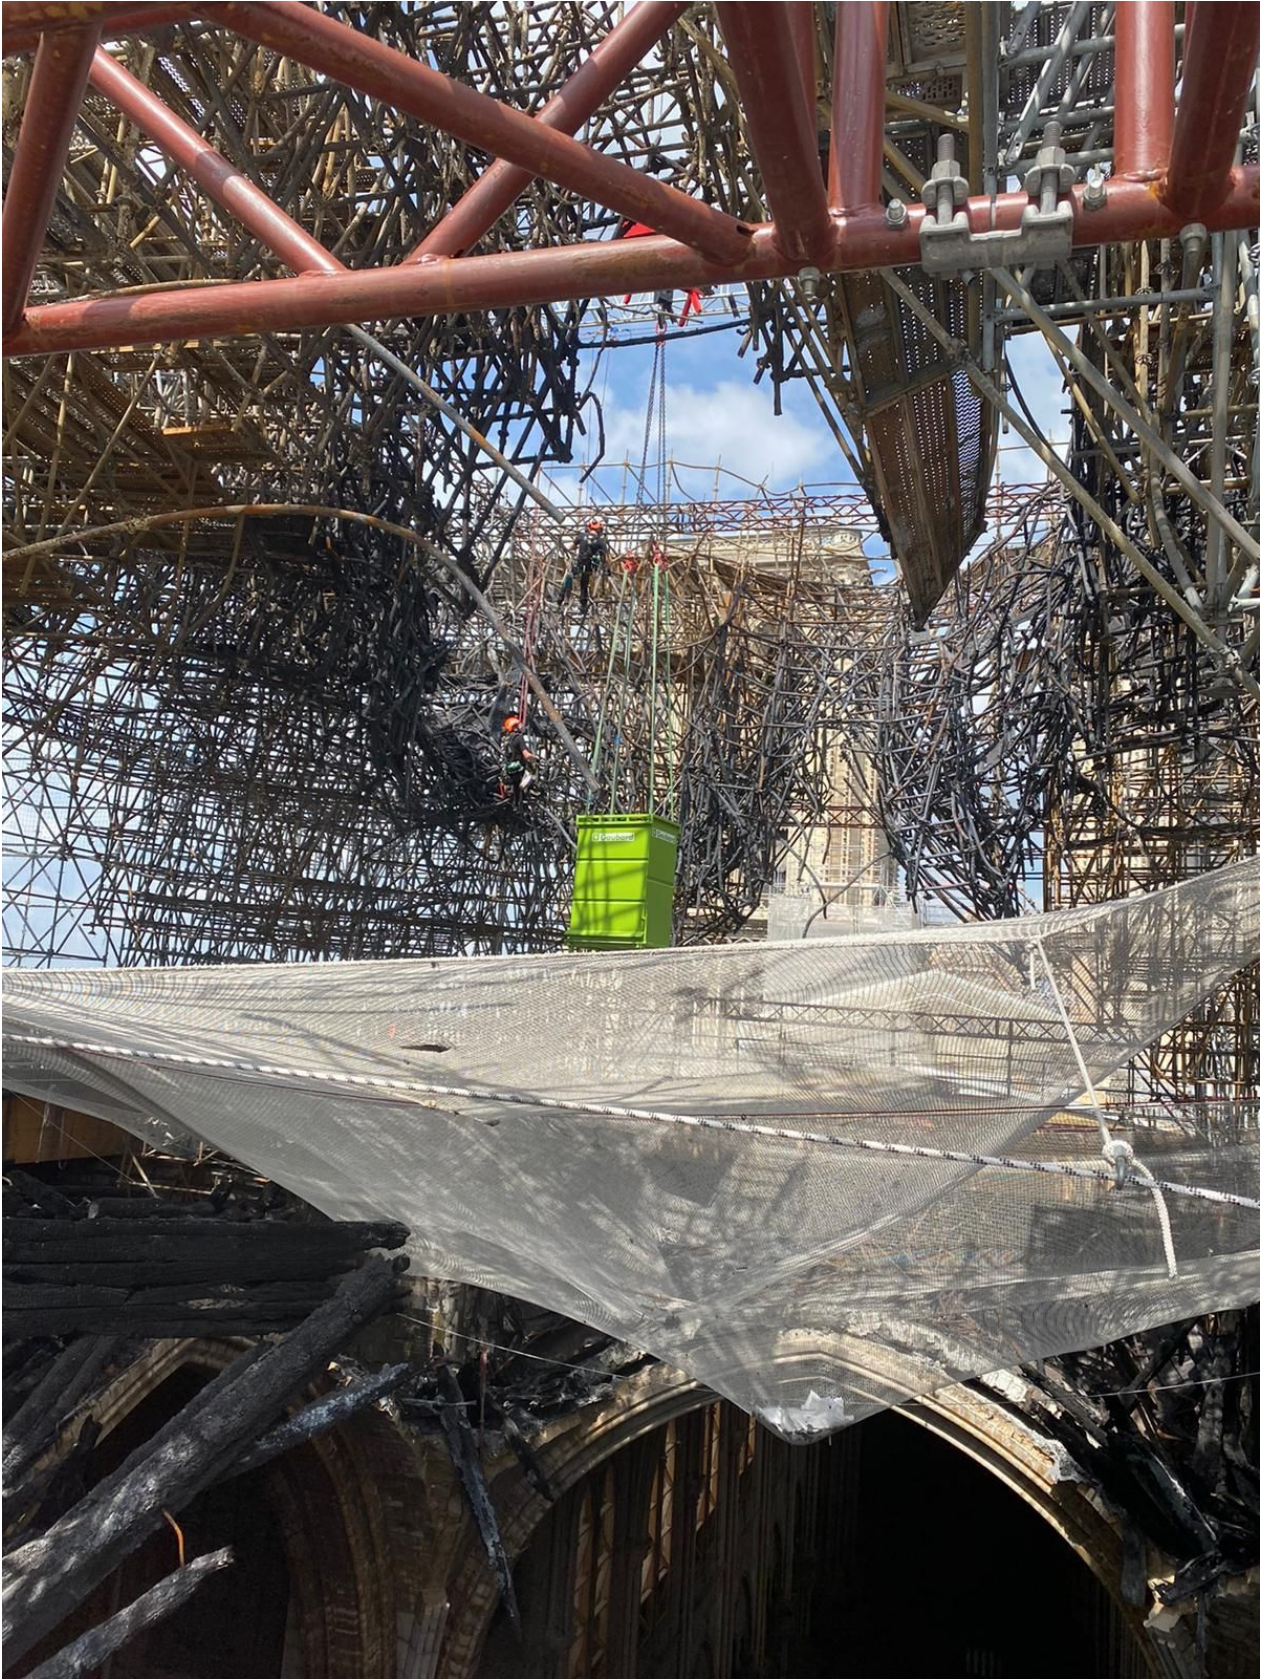
Roped-up workmen dismantling the fused scaffolding

The difficult process of removing the 250 tons of semi-fused steel scaffolding, which had been erected for the restoration of the spire prior to the fire, was suspended for several months due to the coronavirus lockdown but re-started in early June. A tall crane has had to be installed by the side of the cathedral to allow roped-up workmen to get inside and cut away the tubes. This is being done gradually, starting from above and the middle in order not to unbalance the massive tangle of metal. Work is carrying on around-the-clock and is planned to be complete by October 2020.

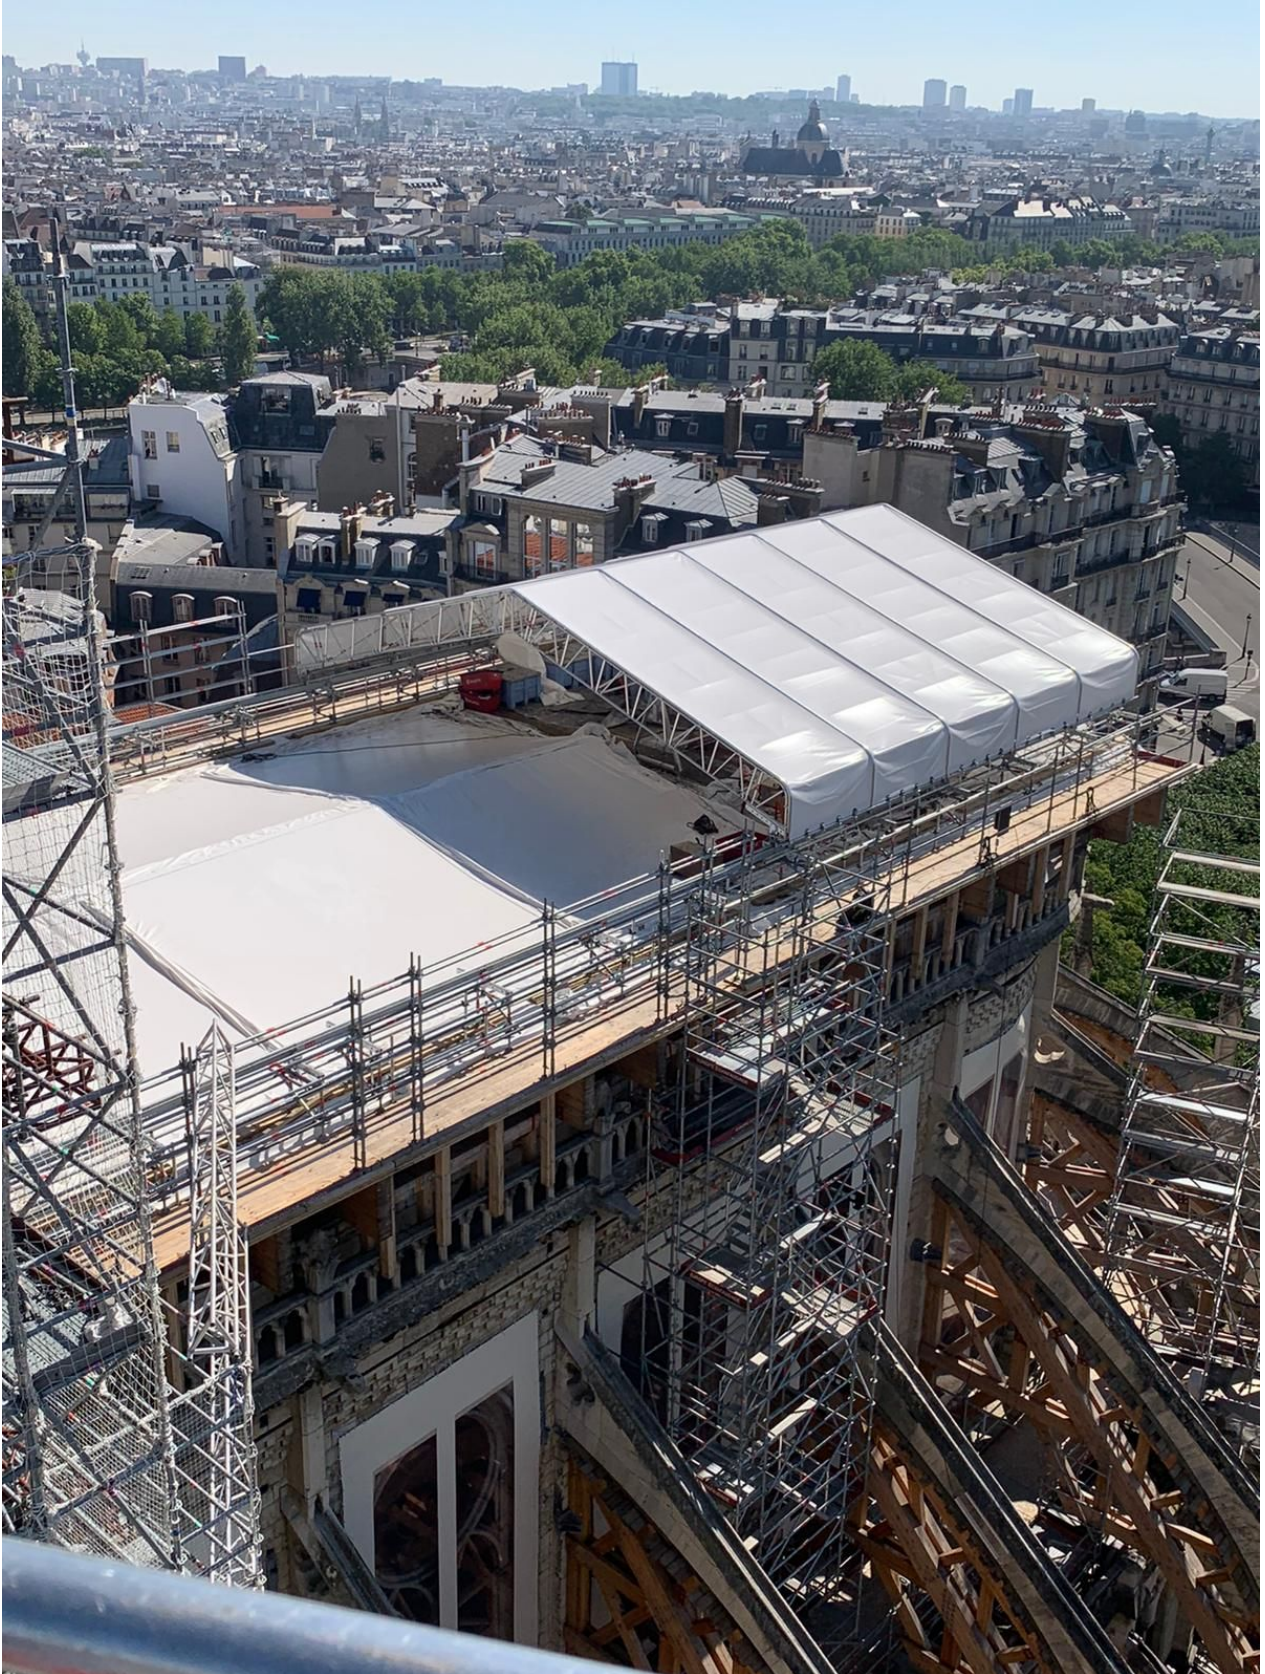
### The rolling platform (parapluie roulant) over the choir

restoration begins. A rolling platform (*parapluie roulant*) has been put over the choir and nave to allow the workmen move around without walking on the vaults. Debris and the burnt beams are being removed, with two-thirds of the choir's vaults already clear and work starting now above the nave. This operation should also be complete by September or October.

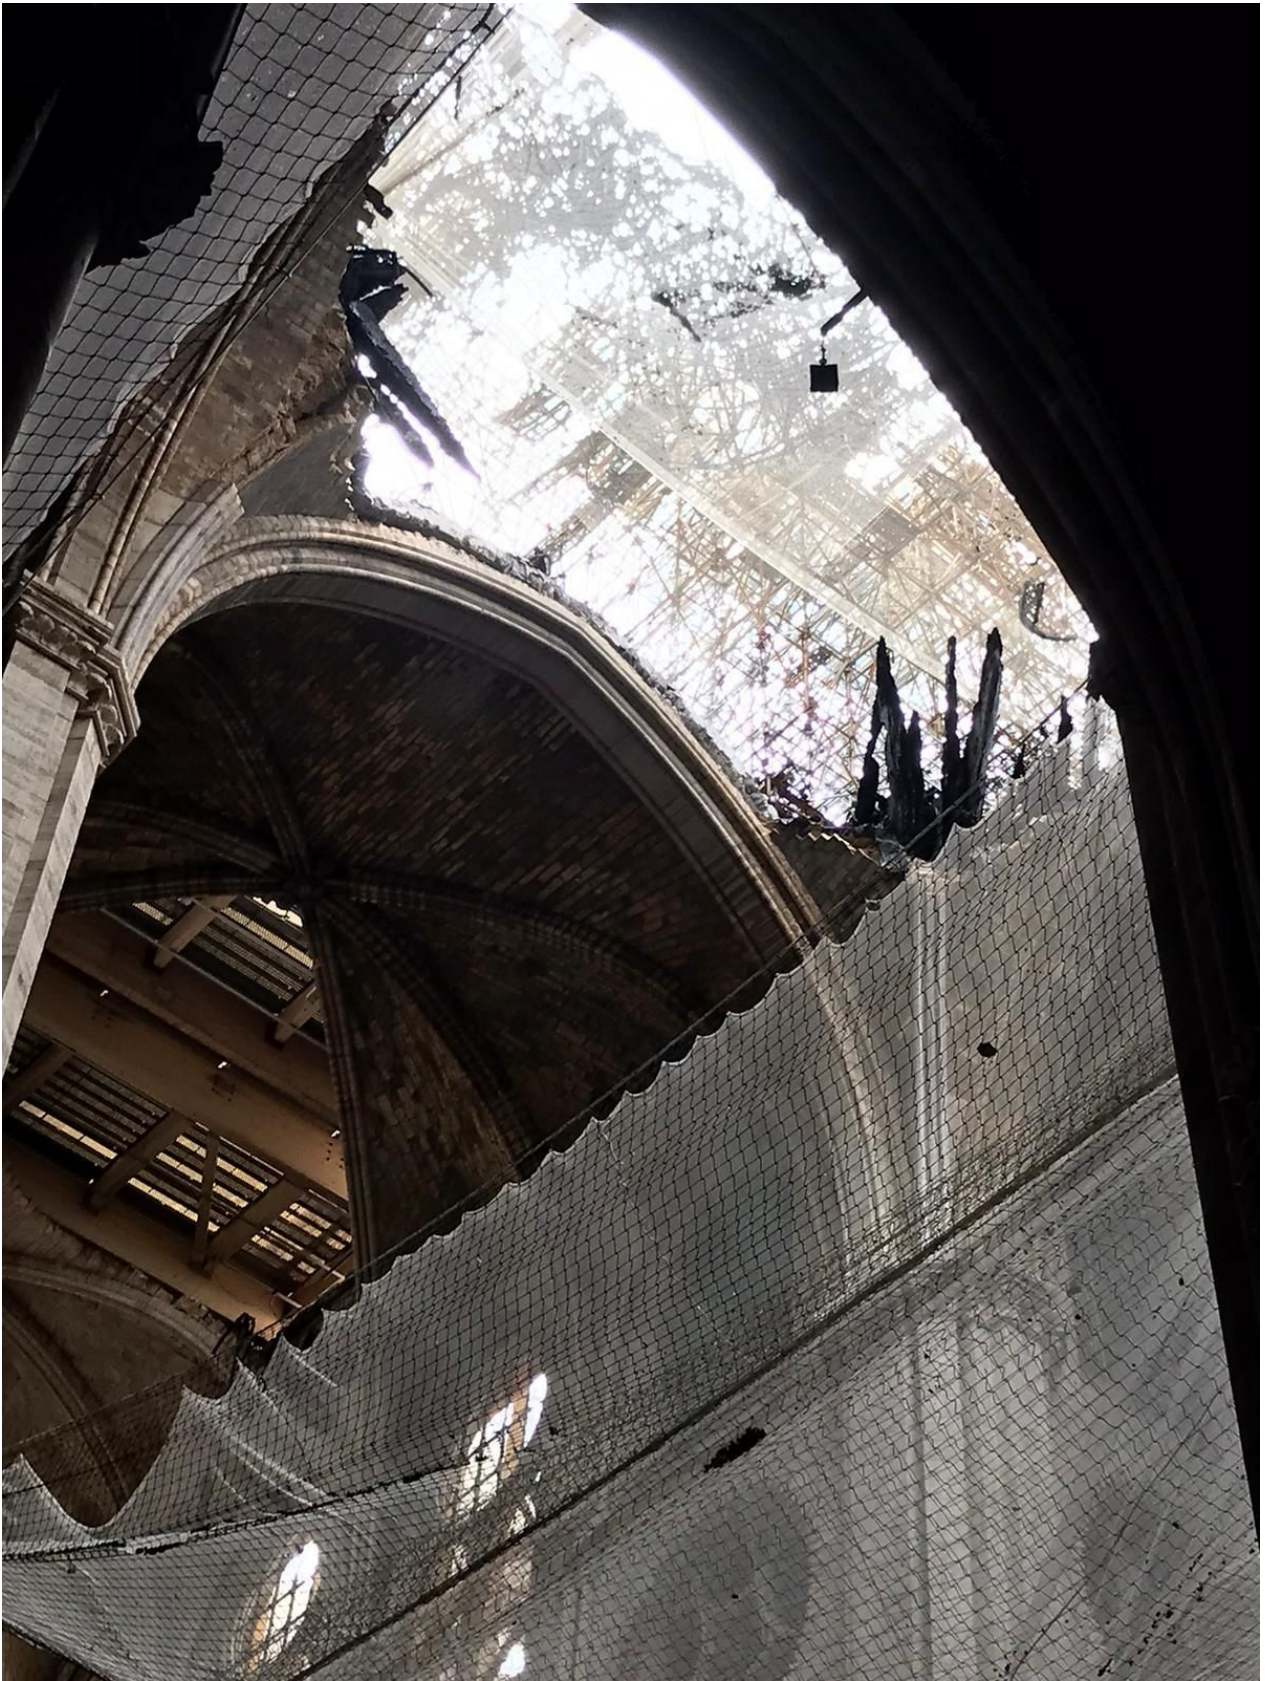
The crossing of nave and transept as it looks today

Close examination of the vaults has revealed that the heat of the fire penetrated the 15cm-thick stone structure to a depth of 2cm. While this does not threaten the overall stability of the vaults, they will require major consolidation. Layers of fibre-reinforced material will have to be applied to the stone surfaces to strengthen their structure at the same time as remaining flexible. There are also five breaches in the vaulting that will have to be filled in first and scaffolding will be erected inside the cathedral to allow access from below. The vaults of the crossing, which collapsed completely, will be rebuilt after the new spire is finished. The entire reconstruction is scheduled to be finished by 2024.

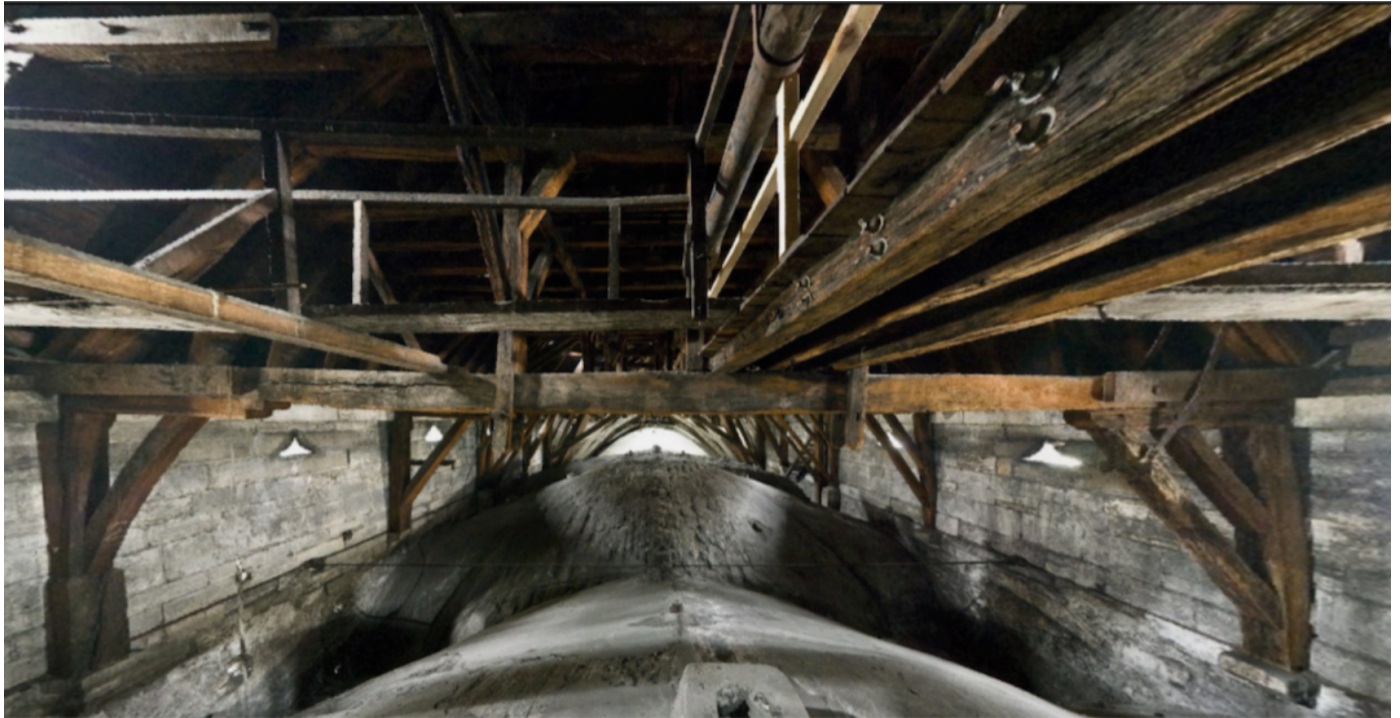
The timbers of the roof over the choir before the fire

Following the recommendations of the Commission nationale du patrimoine et de l'architecture, the roof and spire will be rebuilt in the original manner. The building techniques for these complex timber-framed roofs (*trait de charpente*), which are considered so exceptional as to deserve inclusion in the Unesco's List of Intangible Heritage, go back to the Middle Ages and have been kept alive in France by the training centres of the *compagnonnage*, the carpenters' ancient guild system. Furthermore, the original roof structure of Notre-Dame was recently studied in great detail by Paolo Vannucci of the university of Versailles, and he has clarified and calculated all its structural solutions. The roof over the choir and nave will be built in the traditional manner with freshly harvested oak trunks, cut by hand, as in the past. The wooden structures over the crossing and of the spire will, instead, be built with seasoned, machine-sawn wood, just as by Viollet-Le-Duc. After the spire has been rebuilt, the statues of the saints that were fortunately removed just days before the fire will be replaced.

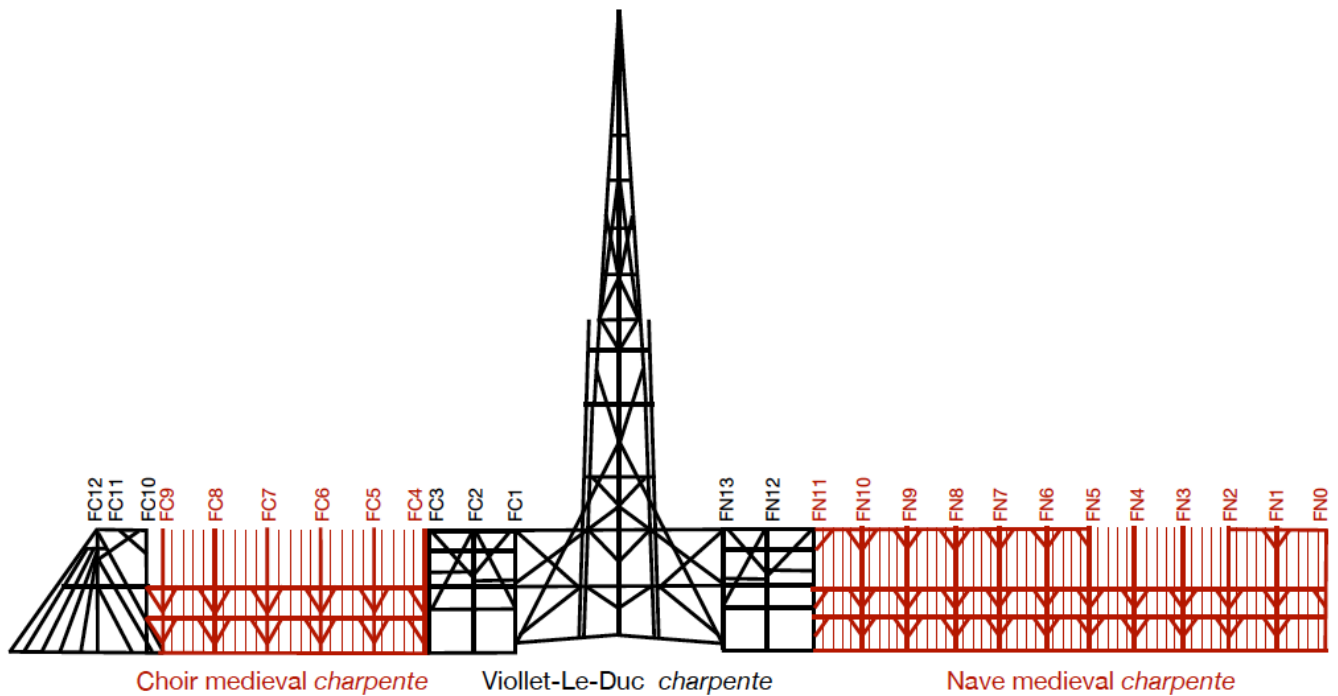
Drawing of the carpentry of the roof and spire of Notre-Dame, showing the different phases of construction
